ABRAHAM LINCOLN BIRTHPLACE
MEMORIAL BUILDING

HISTORIC STRUCTURE
REPORT

Cultural Resources, Southeast Region
National Park Service

January 2001

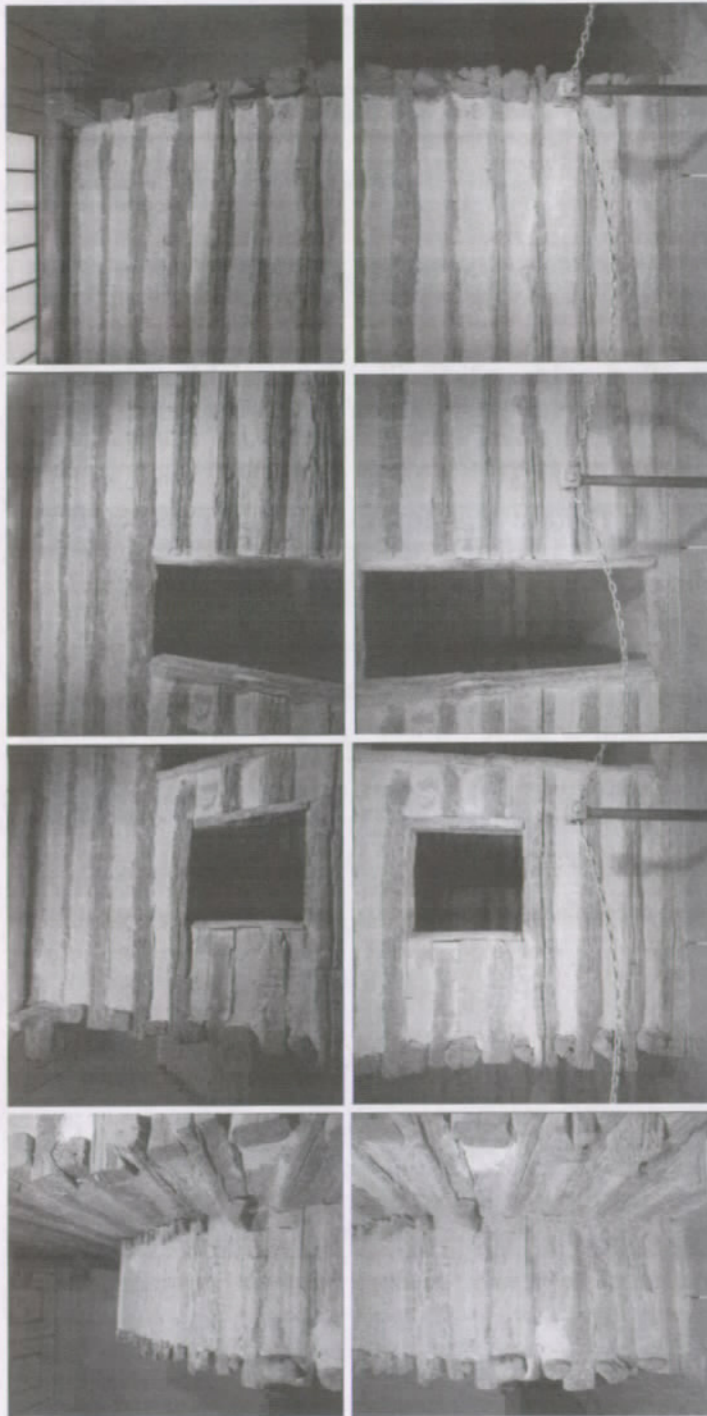
Figure 21 Abraham Lincoln Birthplace National Historic Site, condition of exterior south wall of traditional Lincoln birthplace cabin. Photographs taken June 2, 2000. National Park Service, Southeast Region Cultural Resources library.

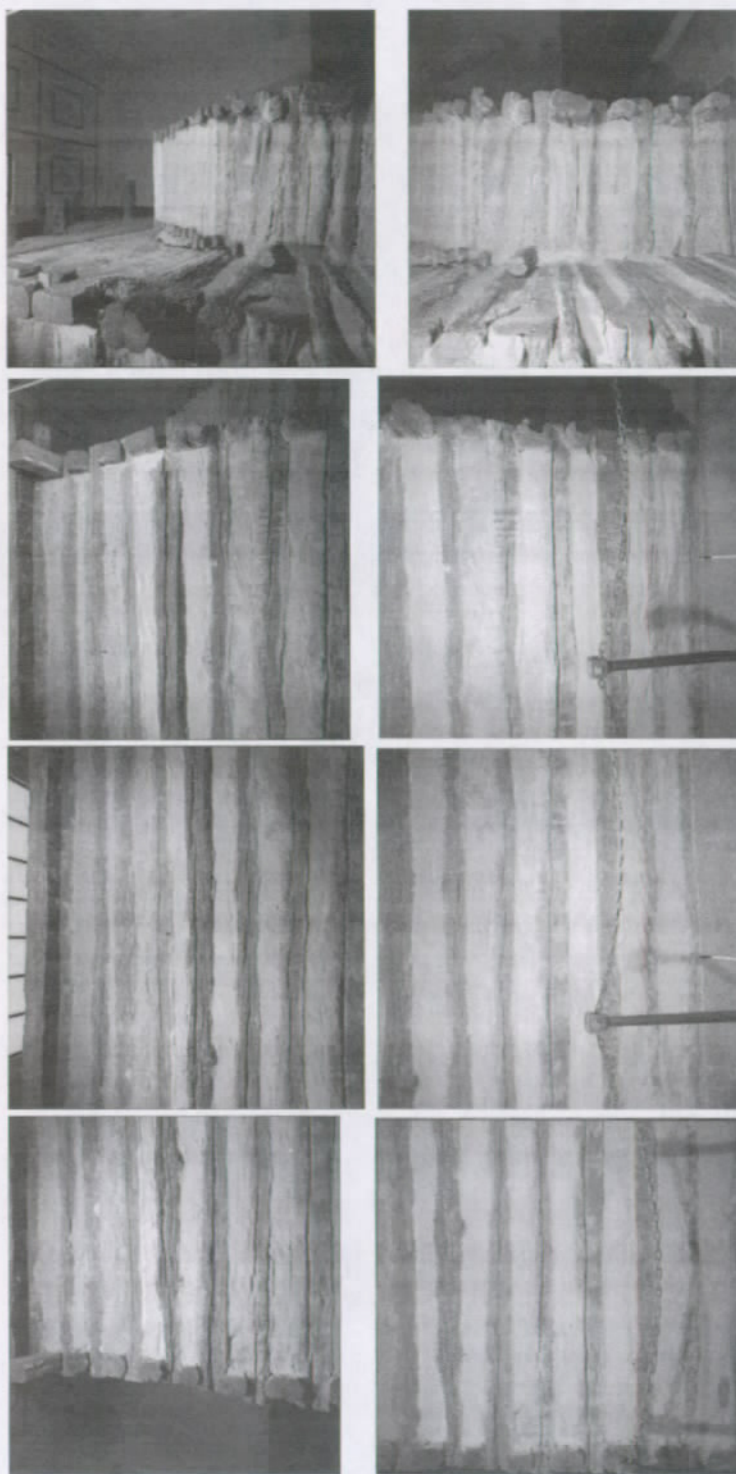
Figure 22 Abraham Lincoln Birthplace National Historic Site, condition of exterior north wall of traditional Lincoln birthplace cabin. Photographs taken June 2, 2000. National Park Service, Southeast Region Cultural Resources library.

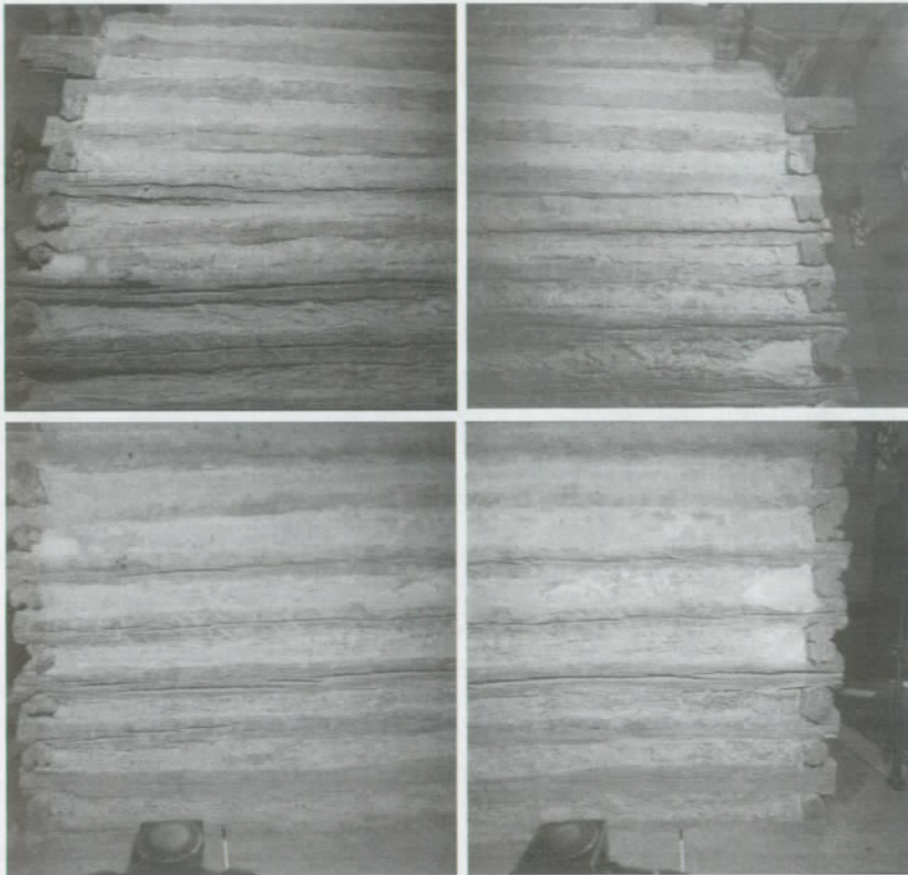
Figure 23 Abraham Lincoln Birthplace National Historic Site, condition of exterior east wall of traditional Lincoln birthplace cabin. Photographs taken June 2, 2000. National Park Service, Southeast Region Cultural Resources library.

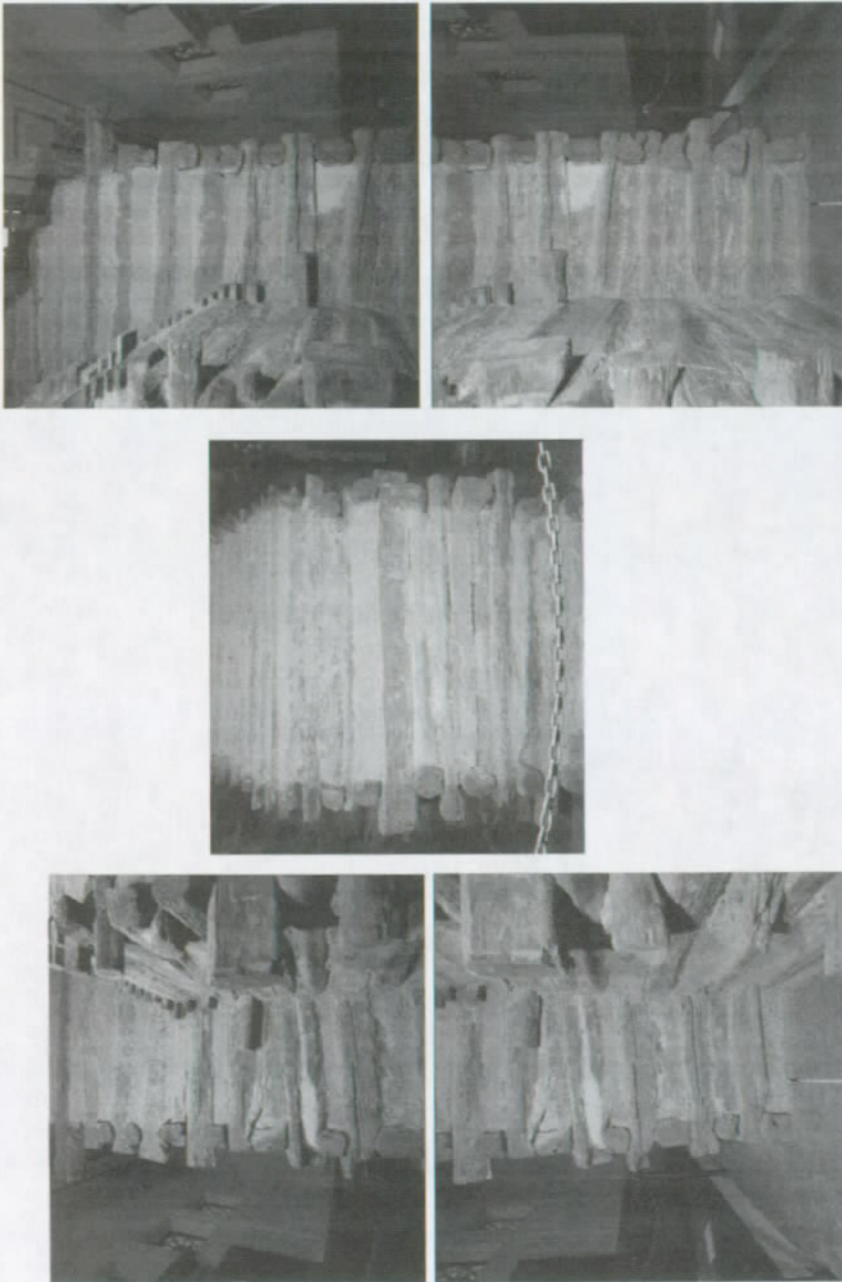
Figure 24 Abraham Lincoln Birthplace National Historic Site, condition of exterior west wall of traditional Lincoln birthplace cabin. Photographs taken June 2, 2000. National Park Service, Southeast Region Cultural Resources library.

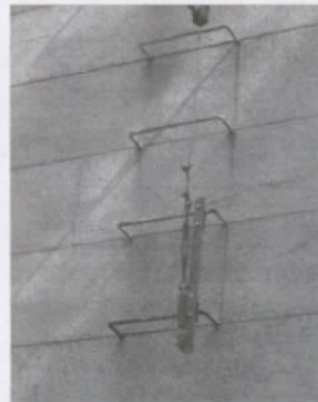
DEFICIENCY: Dirt and mildew buildup on cornice at north elevation. Rusting from the metal roof ladder on the North side has stained the surrounding stone.

Rusting from the metal roof ladder

RECOMMENDATION: Clean dirt and mildew with water, detergent and soft bristle brush (check mortar joint prior to cleaning). Remove rust by applying a poultice material to the affected area to draw the stain out of the stone.

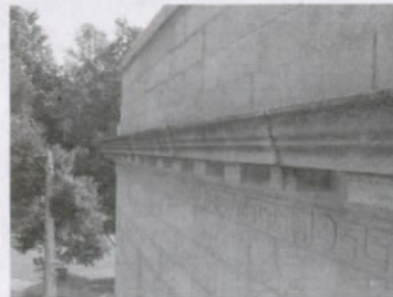
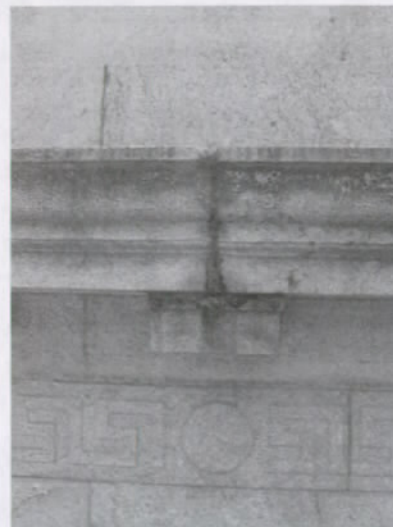
Dirt and mildew buildup on cornice at north elevation (above and below)

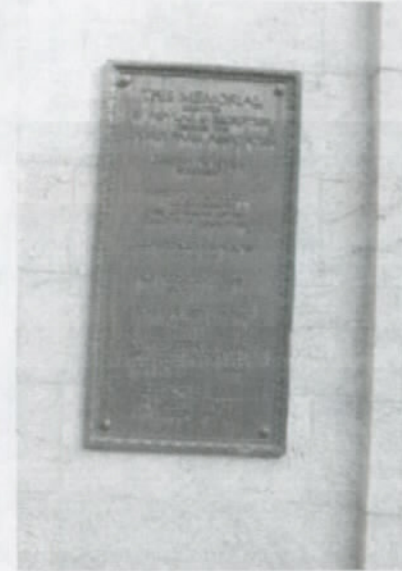
East plaque (Erection Team)

DEFICIENCY: These two plaques are now black with corrosion showing in a few areas.

RECOMMENDATION: Cleaned and restore by a metals conservator. Special care should be taken to preserve the original texture of the metal ground behind the lettering.

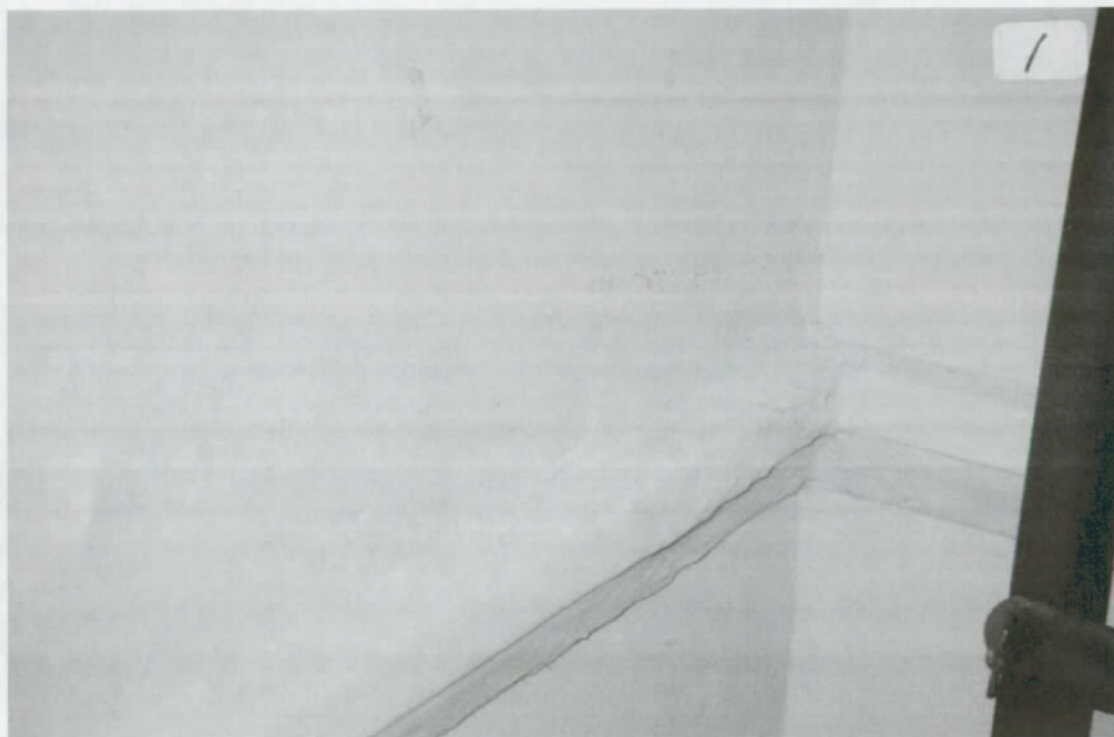
Figure 1. View of picture moulding repair work in the northeast corner. Note poor resolution of profile.

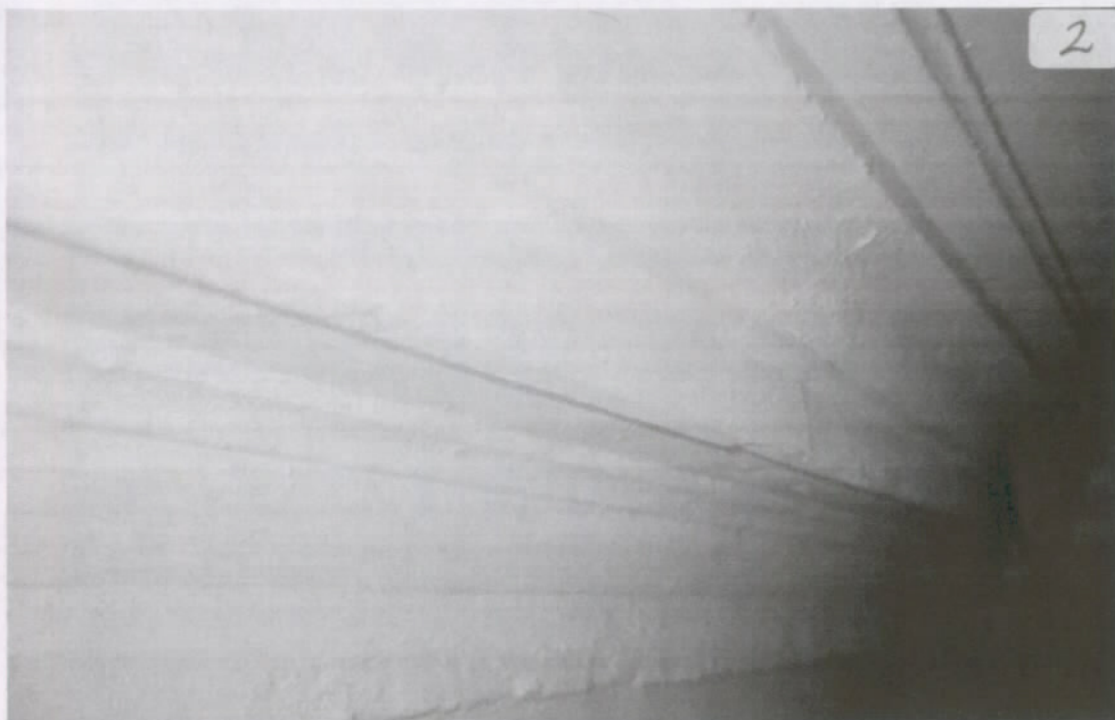
Figure 2. Cornice repair work along the north wall. Again, note poor repair of moulding profile.

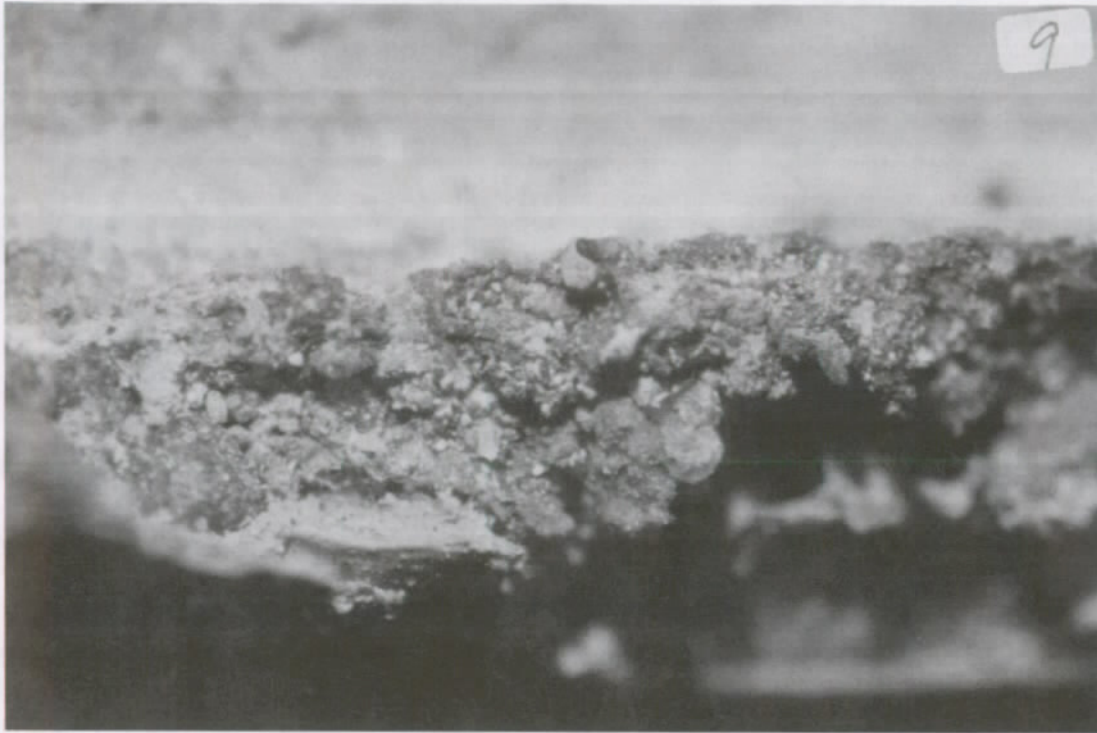
Figure 4. Photomicrograph of brown coating suggests possible sanded paint, to replicate brownstone, perhaps. The thickness, texture, and inharmonious color may be reasons why it was mostly removed.

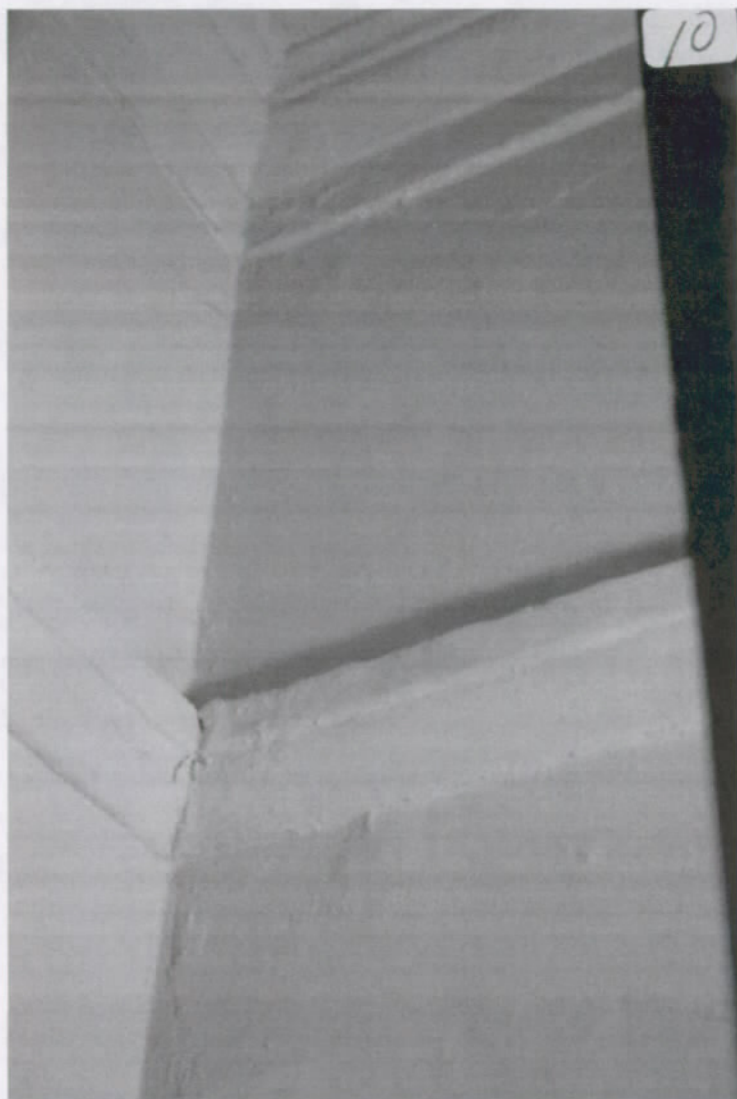
Figure 5. Poor plaster repairs of mouldings in northwest corner.

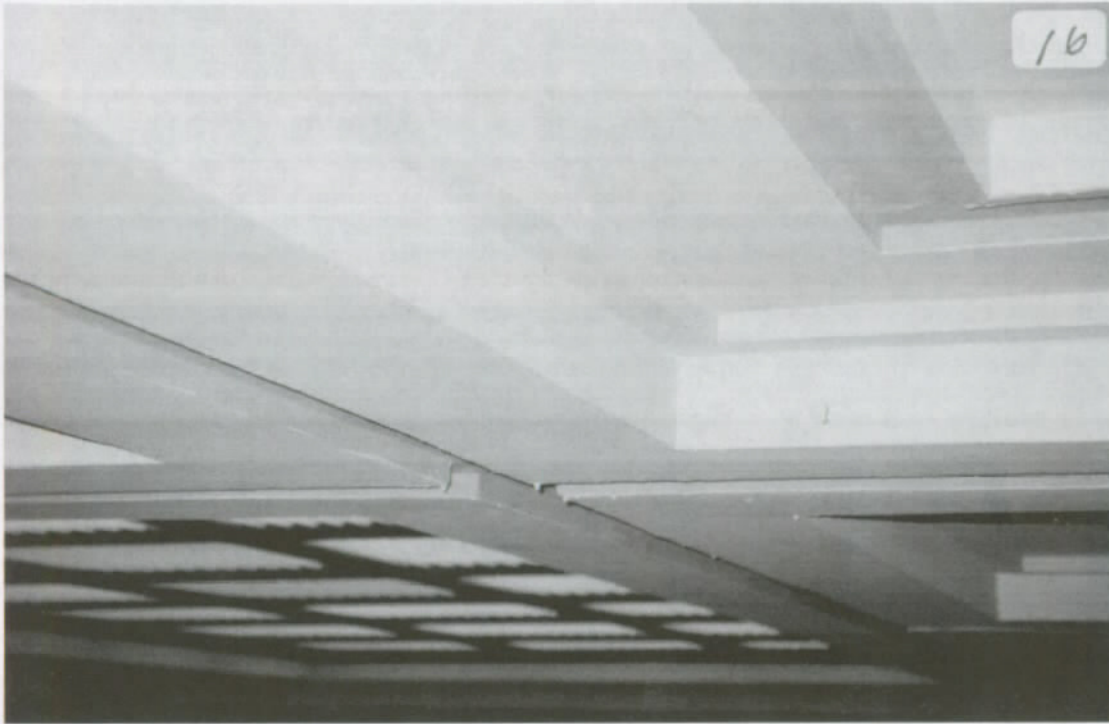
Figure 6. View across ceiling showing drips ("stalactites") of sprayed-on recent thick coating.

The surface of the walls must be refinished to remove paint splatter and drip from decades of paint applications. This is especially problematic along the molding and other articulated surfaces like the ceiling rosettes. The walls were last repainted in 1992, and have been done so at a frequency of every 7 to 10 years. The recommendation calls for a return to the original earth-tone color scheme. (see Paint Study, Appendix G)

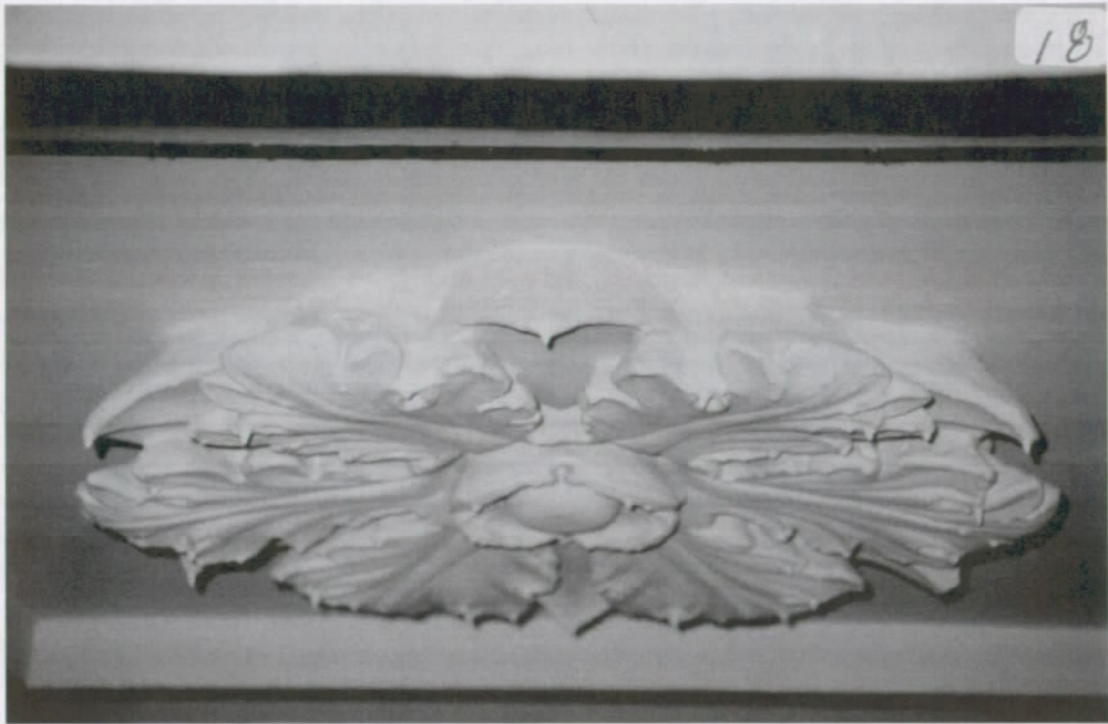
Figure 7. View of ceiling rosette showing drips of sprayed-on thick coating. Typical of all ceiling rosettes.

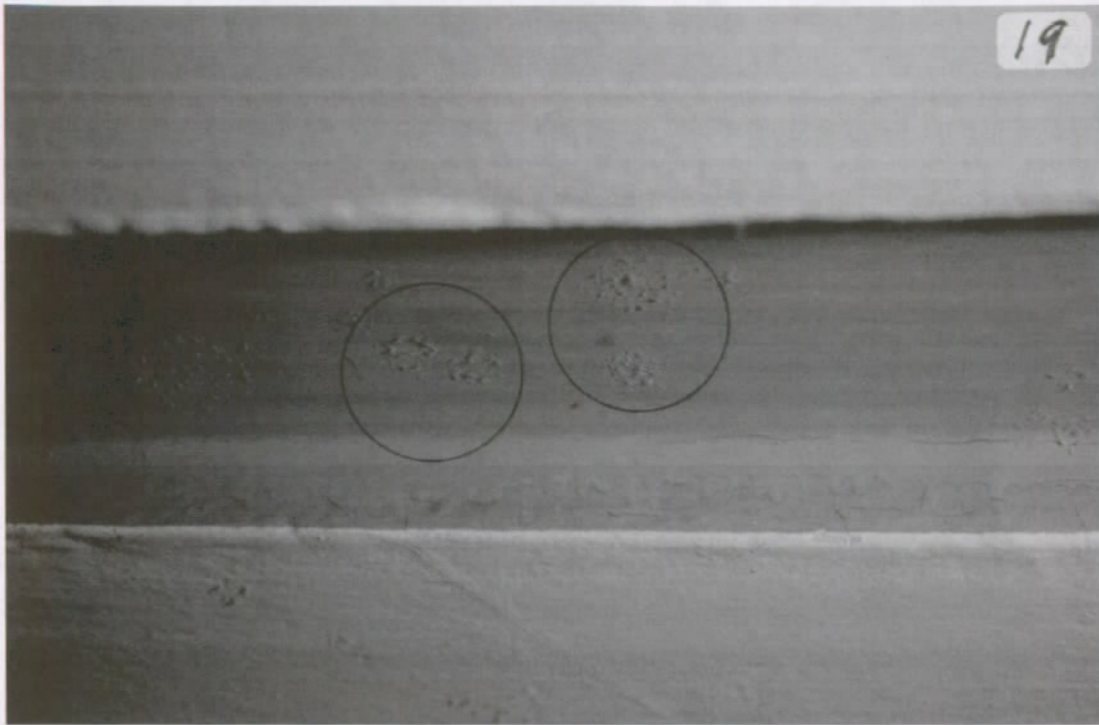
Figure 8. View of mycelia colonies on ceiling in southeast corner. Difficult to photograph.

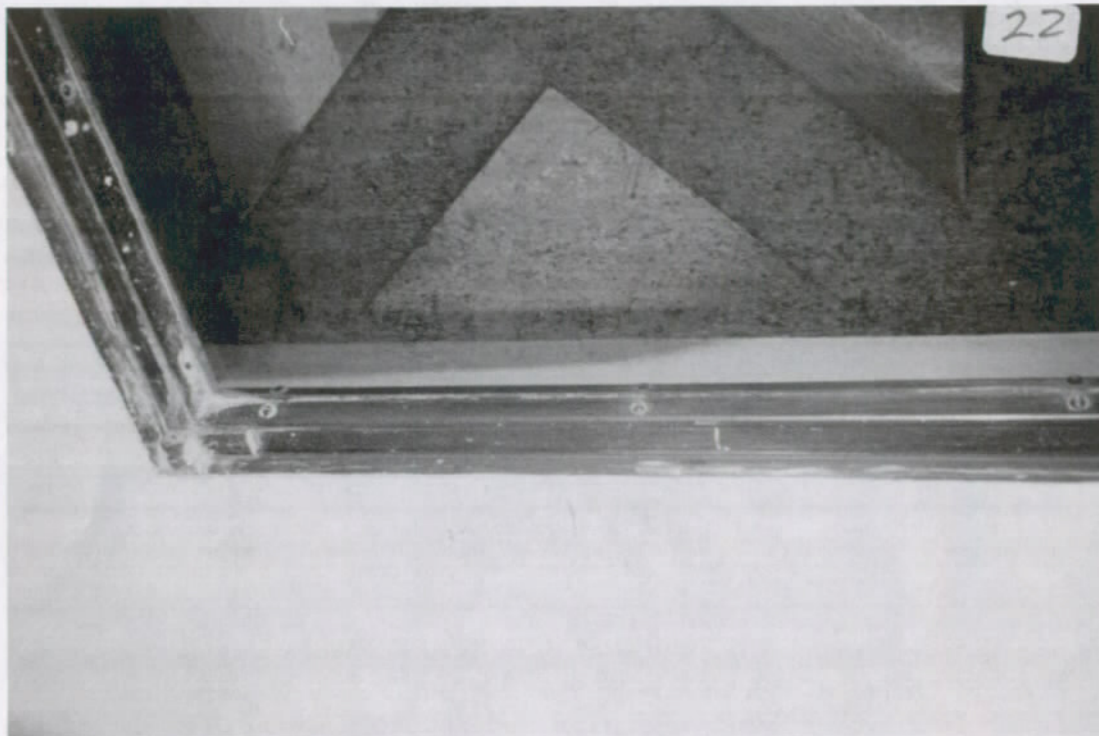
Figure 9. View of typical east/west wall window, showing bronze interior frame. Note sloppy paint work.

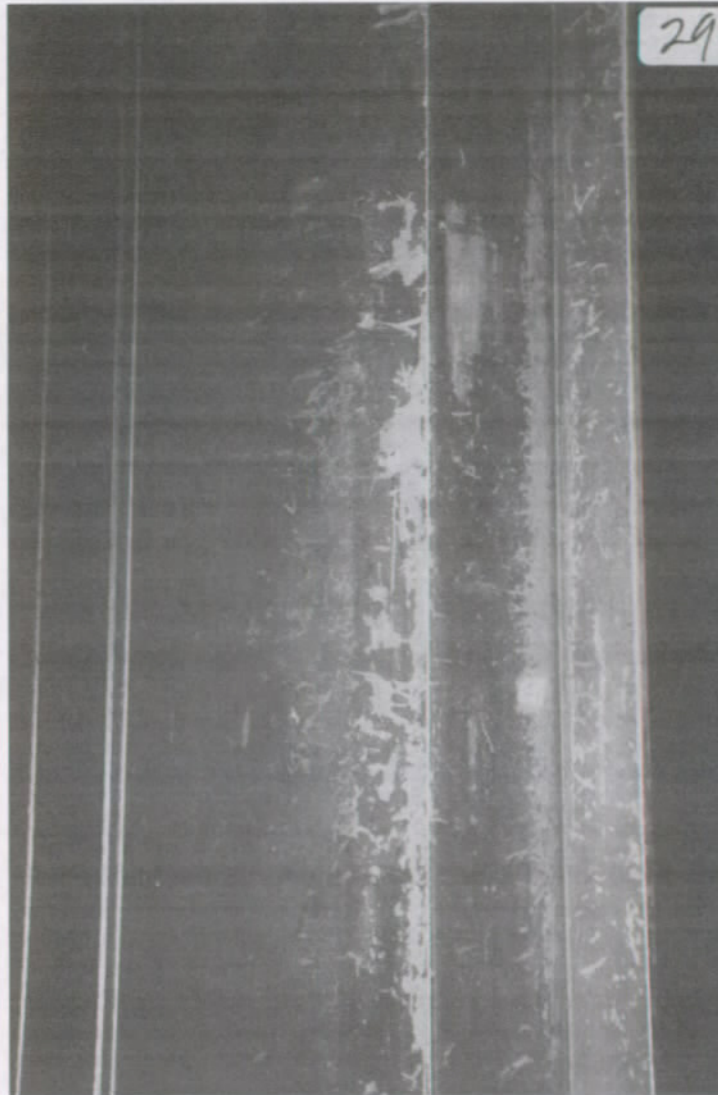
Figure 10. Severe deterioration of coatings and patina, typical on edges of all bronze doors.

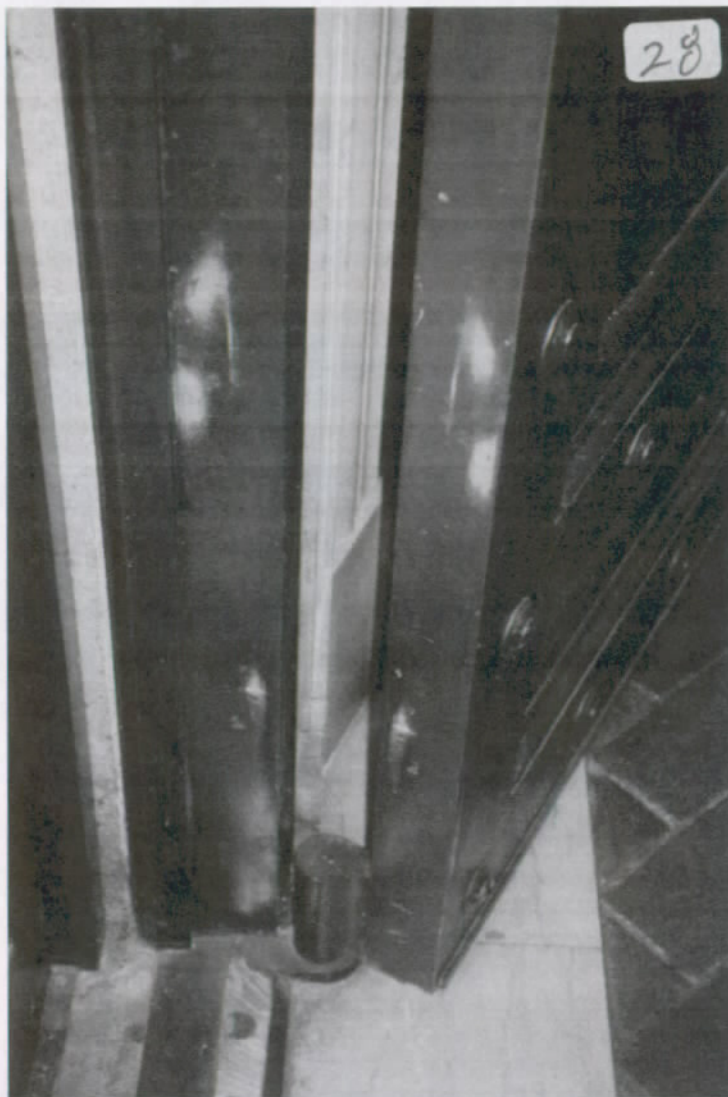
Figure 11. Unexplained damage on hinge side of south bronze door.
